AVIATION INVESTIGATION REPORT

A00A0076

COLLISION WITH WATER

BELL 212 C-GCHG

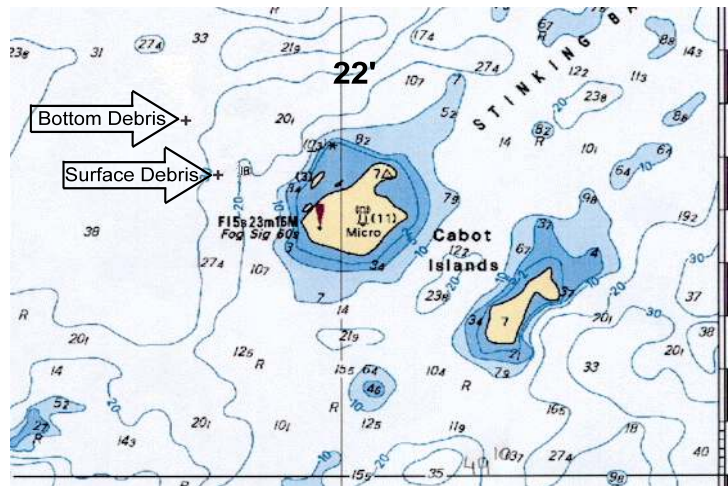
Figure 3 - Wreckage location

The floating debris was located immediately and recovered by local surface craft. Underwater search operations commenced on May 11 at 2300 using an underwater remotely operated vehicle. The underwater search, which was hampered by adverse weather, rough bottom conditions, and extensive underwater currents, continued until aircraft debris was located late in the evening on May 20. The main wreckage and the pilot were located the next day, 0.3 nm west-northwest of Cabot Island at a depth of 110 feet. The debris field was about 250 feet long, with the main cabin area to the northeast. The distribution of wreckage items was consistent with the tidal current. Less-dense components, such as the main rotor, panels, and the tail boom, were deposited to the southwest (see Appendix A). The wreckage was approximately 600 feet farther out from, and in line with, the estimated location of the floating netload of barrels observed immediately after the accident.

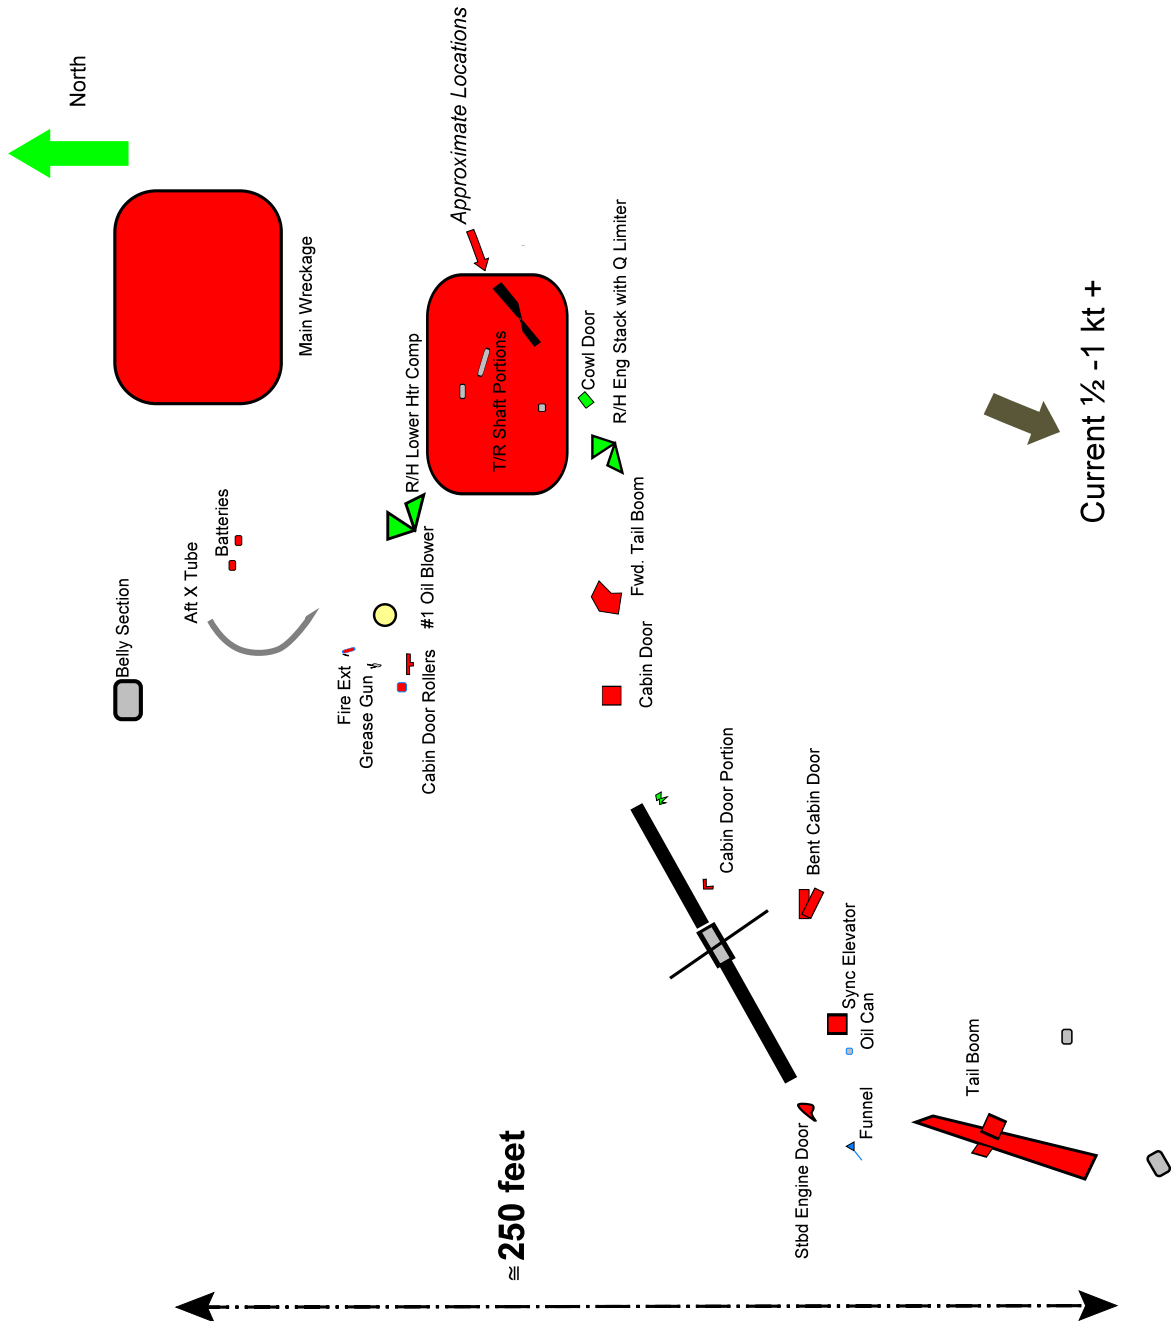
Appendix A—Wreckage Distribution Diagram

The main rotor was found in the southwest portion of the debris field. The tail rotor was recovered with other tail-rotor drive components in the middle portion of the debris field, just south of the fuselage cabin. An examination of the tail rotor revealed that the tail-rotor drive had separated in flight as a result of overload forces generated during the break-up sequence. The failure sequence of the tail-rotor components could not be determined.

A characteristic of in-flight rotor/mast separation accidents is the differing resting locations of the rotor and the airframe. After separation, the airframe descends ballistically on its last track. The rotor, however, may continue to fly a substantial distance before impact. In this occurrence, the location of the main rotor within the debris field suggests that the rotor/mast separation took place at a low altitude. The flight profile did not require low-G manoeuvres, and it is unlikely that an experienced pilot would inadvertently induce low rotor loading during a routine mission over a flat surface. It is likely that drag forces from the load/water contact caused a sudden aircraft upset, mast bumping, and main-rotor separation. In-flight damage to the flight controls caused by the hook assembly tearing away could have contributed to excessive flapping angles and may also have prevented the pilot from recovering from the sudden aircraft upset.
